**RHINO**  
CARBON FIBER  
REINFORCEMENT PRODUCTS

CORNER WRAP CASE STUDY

# BLOCK WALL CORNER REPAIR

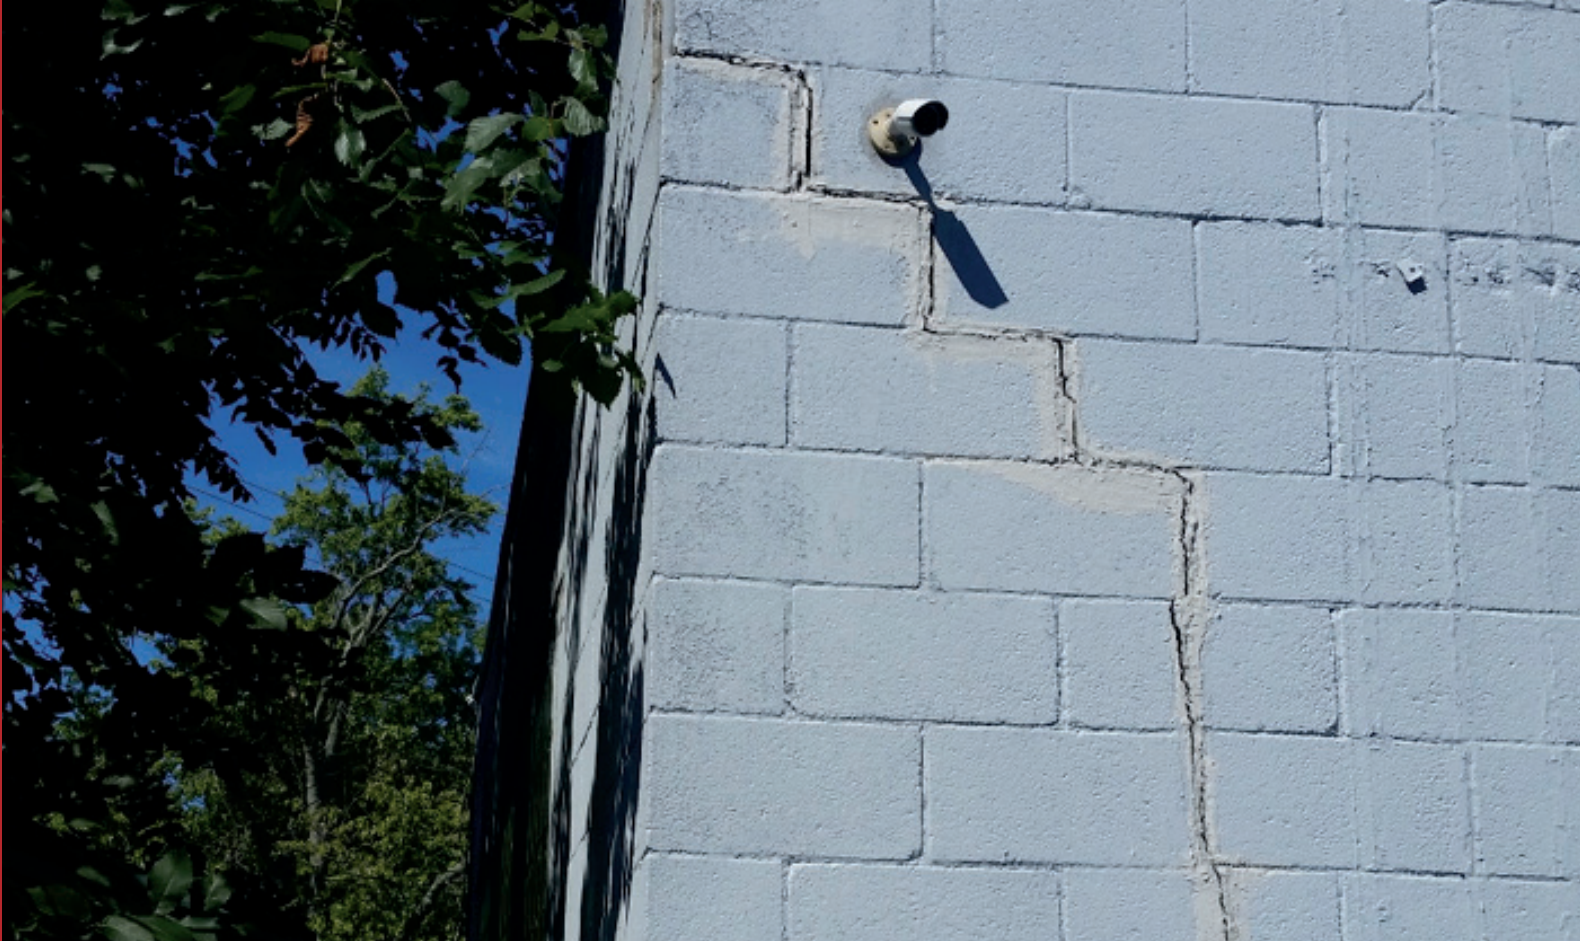
The exterior wall of a building in New Jersey was built using concrete blocks, and over time cracks started to form. Attempts had been made to repair the structure, but each time the cracks reopened and got worse. The Concrete Chiropractor, a concrete repair contractor, was called in to discuss repair options on the structure.

The Concrete Chiropractor reviewed the project and their analysis determined that the best solution was to install 400 GSM, 24" wide **Rhino Carbon Fiber CFRP (Unidirectional, Horizontal)** over the crack and 560 GSM, 12" wide **Rhino Carbon Fiber CFRP (Bidirectional)** over the corner applied with **RCF Saturant-Adhesive Epoxy**. This solution was determined to be the best option because if slight movement in the block wall joints remained, CFRP would resist this movement and remain intact.

The block wall was prepped and all mortar joints were filled with hydraulic cement, then the CFRP was installed. The repair avoided using traditional methods that involve excavation and a large footprint, and the project was completed in a timely manner. High quality products from **Rhino Carbon Fiber** enabled the the Concrete Chiropractor to repair a problem crack that was holding up the sale of the property. Once repainted, the repair blended nicely, effectively restoring the aesthetic appeal and structural integrity of the building.
