## CFRP CASE STUDY

# RESIDENTIAL BOWED BLOCK (CMU) WALL REPAIR

Hastings, New York

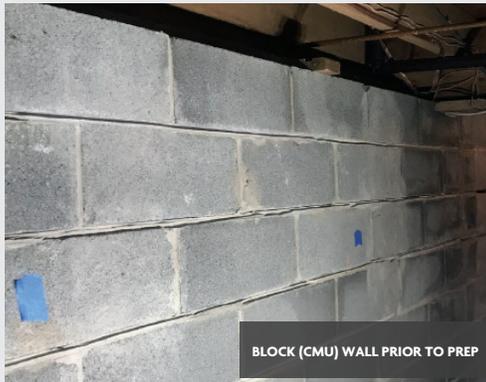
BLOCK (CMU) WALL PRIOR TO PREP

Proper surface preparation is one of the most important steps when installing CFRP. EcoSpect prepared the walls by grinding them to ensure the straps were engaged to their full capacity in order to resist any further inward movement of the wall, and to ensure a strong epoxy bond. Next, they repaired the damaged mortar joints. To complete and ensure the repair was water-resistant, the cracked mortar needed to be knocked out and the joints were tuck-pointed. If the joints were not repaired properly, the walls were at risk of receding during the summer months when the moisture content of the soil is lower. Allowing any movement of the wall will further deteriorate the mortar joints which could create a wrinkle in the carbon fiber, decreasing the effectiveness of the repair.

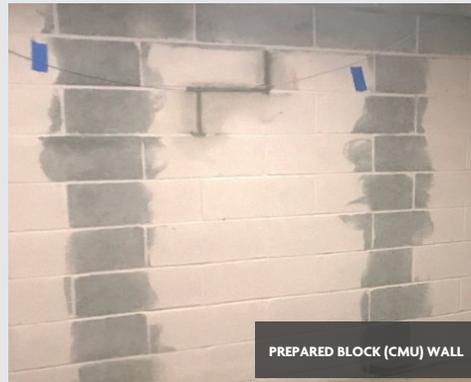
PREPARED BLOCK (CMU) WALL

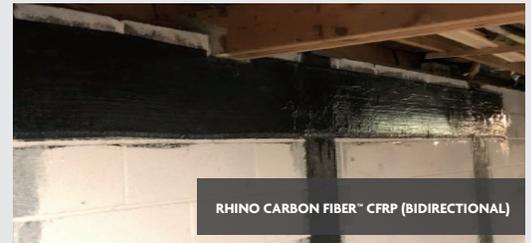
RHINO CARBON FIBER™ CFRP (BIDIRECTIONAL)

Nine **Rhino Carbon Fiber™ Bowed Wall Repair Kits** were applied across the four surface-prepped walls for a total of 26 straps. In addition, a single strap of 560 GSM, 12-inch wide **Rhino Carbon Fiber™ CFRP (Bidirectional)** was applied along the upper course of block over the mortar joint that had started to open up where the movement manifested. The additional bidirectional strap provided strength in all directions. It was applied to increase the bond strength on the ends of the straps eliminating the possibility of a premature bond failure.

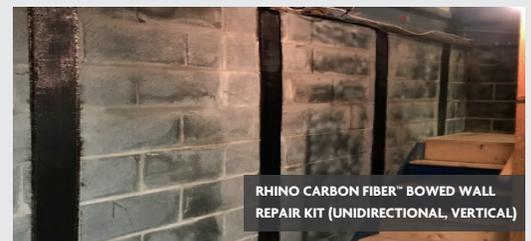
RHINO CARBON FIBER™ BOWED WALL REPAIR KIT (UNIDIRECTIONAL, VERTICAL)
